Mitigating fouling in crude distillation columns

Case study on increasing crude column throughput by using fouling-resistant trays in the kerosene section

Abhijit Gogoi **Nayara Energy Limited**
Neil Sandford and Sandeep Yadav **Koch-Glitsch**

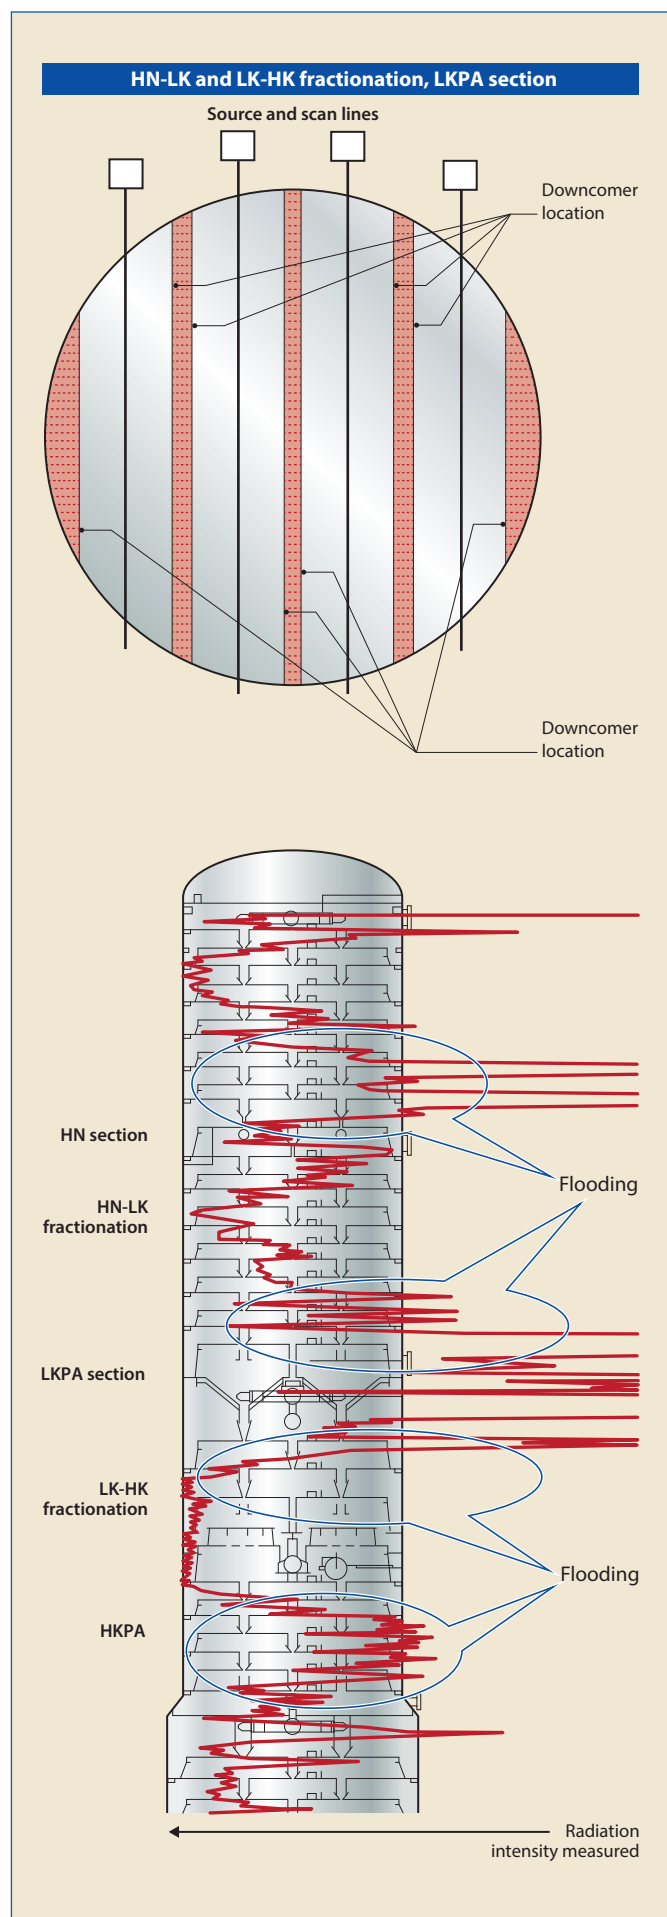
Figure 2 Column gamma scan

Although the study indicated that fouling was the possible root cause of the increased pressure drop across the column, a gamma scan of the crude column was performed to pinpoint the exact location of flooding. Four scan lines were used to evaluate the column's hydraulic performance, with one of these scan lines represented in **Figure 2**. The scan results provided the following interpretations:

- Liquid accumulation and flooding were observed in the top section of the column down to the HN draw section, predominantly in the mid-zone. The bottom of this section showed very little liquid, indicating that the top section trays were holding the liquid while the bottom was drying up.
- Liquid accumulation and flooding were also noted in the mid-section between the HN draw and LKPA return.
- The LKPA section trays were found to be flooded at the bottom, with a significant pile-up of liquid.
- The trays in the LK draw to HKPA return section appeared to be flooded at the top, with less liquid observed at the bottom of this section, indicating a liquid build-up at the top.

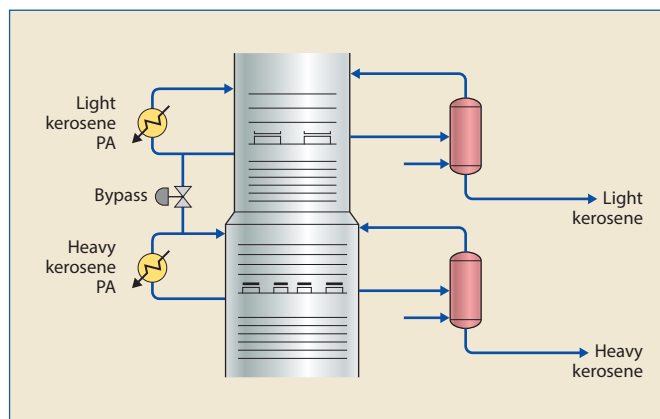
Figure 3 Arrangement of routing LKPA to HKPA

To achieve this without shutting down the unit, an unconventional method of routing a slip stream from the LKPA to the HKPA return was devised by NEL. This approach aimed to partially bypass the internal reflux from the LK to the HK zone. The slip stream of LKPA to HKPA return was implemented without affecting the column profile and with minimal adjustment to pumparound duties.

The main challenge was to complete the modification on the operating column and perform a hot tap. A process scheme was developed by NEL, which included taking a hot tap to route a portion of LKPA from the immediate LKPA

pump discharge to the outlet of the last HKPA pumparound exchanger. This scheme was executed and commissioned within a few days (see **Figure 3**). Post commissioning of the slip stream scheme included the following improvements:

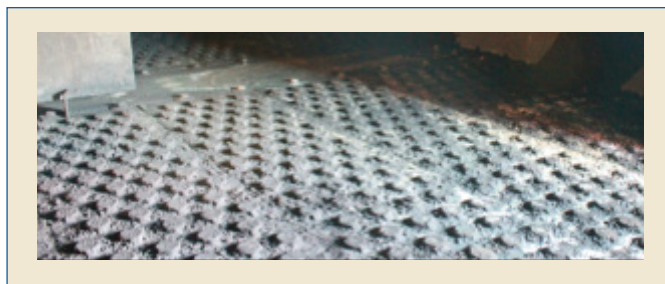
- In the LKPA zone, fouling was noticed on the tray deck, with deposits increasing from top to the bottom tray.
- In LK-HK fractionation and HKPA zones, hard and severe fouling was observed on the tray deck and downcomer area (see **Figure 4**). Most of the valve openings were blocked by deposits, with fouling more prevalent in the mid-section of the tray (see **Figure 5**). All trays were removed, cleaned with a hydro jet followed by grit blasting, and reinstalled. The LK-HK fractionation trays were replaced with new, identical trays. Laboratory analysis of tray deposits revealed significant quantities of phosphorus, along with iron and sulphur.

Figure 4 Fouled tray in LK-HK fractionation section

The analysis of the tray deposits revealed varied appearances, with colours ranging from reddish-brown to black, and a high phosphorus content of approximately 21% by weight. Based on the extent of fouling and the analysis of deposits on the LKPA and HKPA zone trays, it was concluded that fouling was primarily due to phosphate salts, mainly contributed by the type of crude processed and, to some extent, by the high TAN corrosion inhibitor dosage. To prevent such occurrences in the future, it was recommended to replace the trays in these sections with fouling-resistant trays.

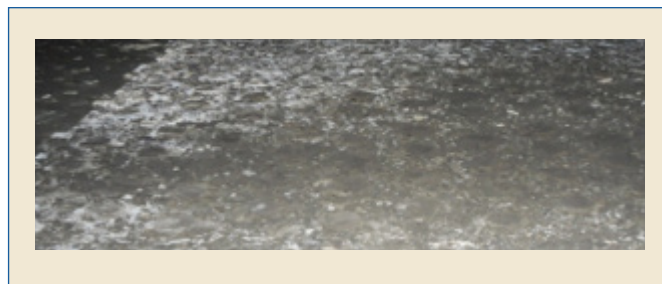
Figure 5 Fouled tray in HK section

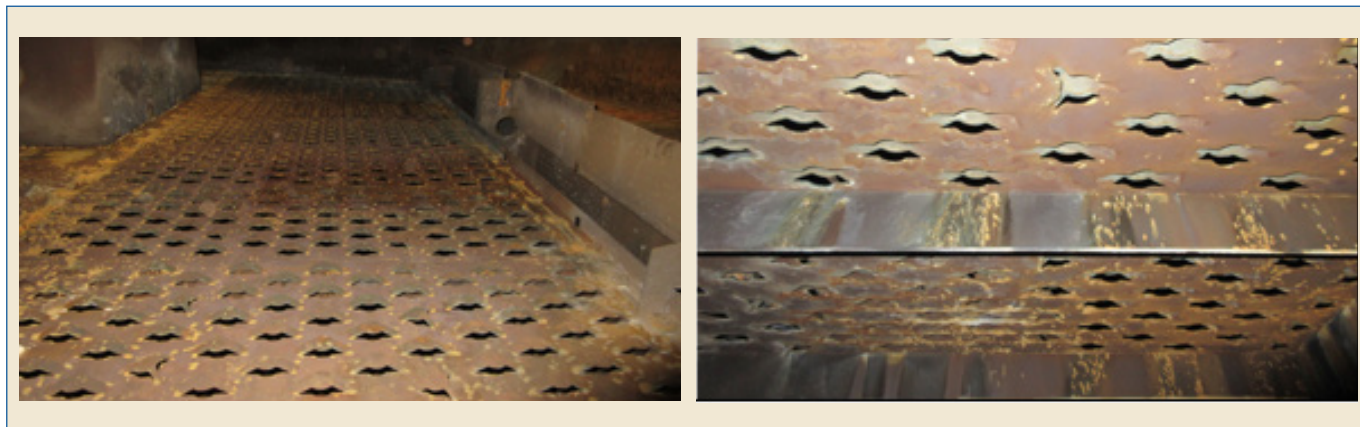
After two years of operation, at the end of 2022, the column was opened and inspected. All trays were found in good condition without fouling (see **Figure 7**). A slight pitting was observed in the top few trays. In the HN-LK section, minor deposits were observed on the tray deck, displaying a blackish colour. Analysis of these deposits indicated a very small phosphorus content, less than 2% by weight. The low concentration of phosphorus compared to the 2018 shutdown clearly indicates the effective flushing of salts from the tray deck, which is attributed to the fouling-resistant properties of the Superflux trays.

Figure 7 Superflux tray after two-year column operation

As a result of these observations, a total of 25 trays from the HN to HK zones were replaced with new Superflux trays to improve fouling resistance. Post-replacement, significant improvements were observed in overall column parameters, including sectional and overall column differential pressure (DP), which remained stable at approximately 0.4 Kg/cm² at equivalent throughput levels. **Table 4** shows the DP profile of the column's top section after replacing the trays.
