Mitigating fouling in crude distillation columns

Case study on increasing crude column throughput by using fouling-resistant trays in the kerosene section

Abhijit Gogoi **Nayara Energy Limited**
Neil Sandford and Sandeep Yadav **Koch-Glitsch**

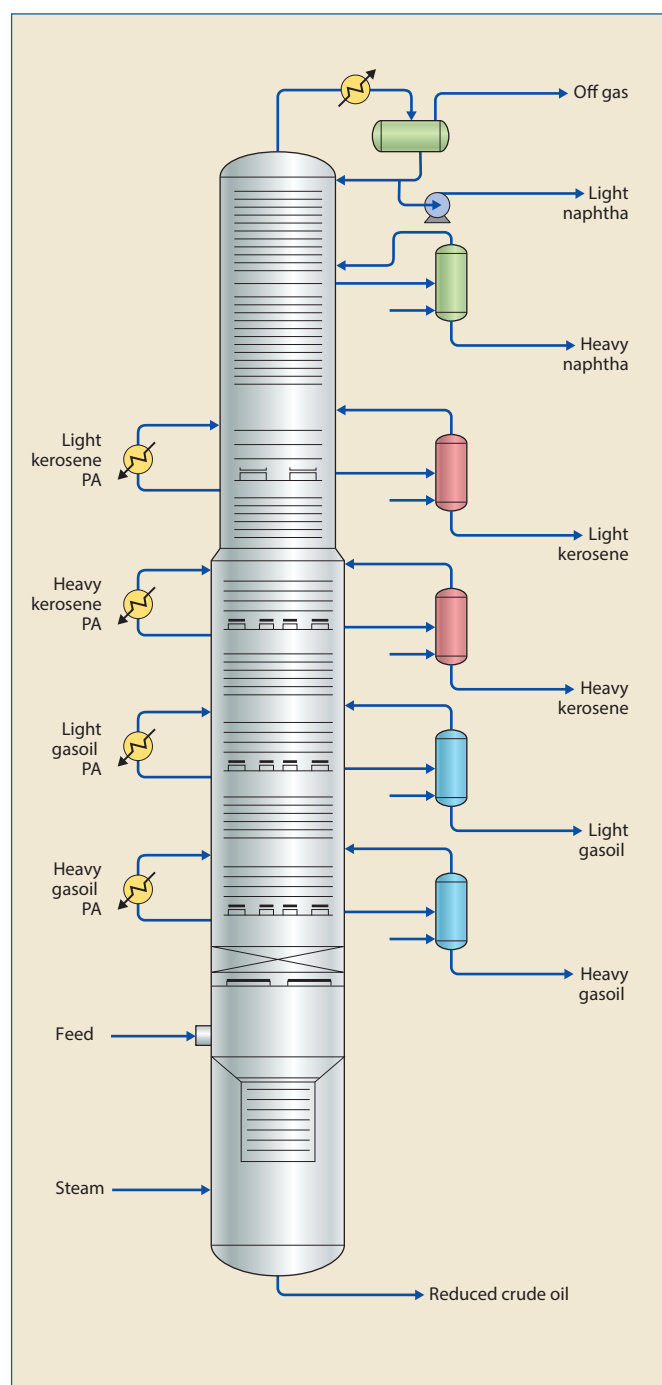
Figure 1 Arrangement of crude distillation column

The Nayara Energy Ltd. (NEL) Vadinar refinery atmospheric (crude) distillation column (CDU) is equipped with trays in the fractionation, pumparound, and steam stripping sections and a packed gasoil wash section above the flash zone. Overhead light naphtha is routed to the saturated gas unit, and reduced crude oil (RCO) bottoms are routed to the vacuum tower as a feed. Five side draw products – heavy naphtha (HN), light kerosene (LK), heavy kerosene (HK), light gasoil (LGO), and heavy gasoil (HGO) from the crude tower – are further processed in secondary units of the refinery. The tower has four pumparounds (PAs): light kerosene, heavy kerosene, light gasoil, and heavy gasoil. **Figure 1** illustrates the overall crude column arrangement.

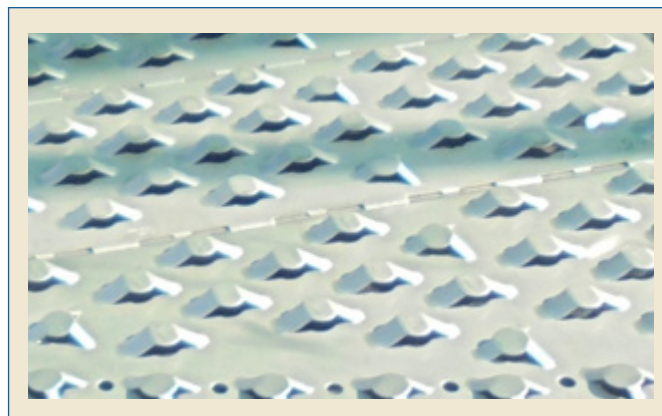
Figure 6 Superflux tray with fixed valves to reduce residence time of solids on tray deck

To extend run times in severe fouling service, fouling-resistant trays with anti-fouling valve options promote self-cleaning of the active areas. These trays have fouling-resistant fixed valves that use vapour energy to create a forward lateral push to the froth, maintaining proper tray activity and reducing the residence time of solids on the tray deck (see **Figure 6**). Special attention is given to the peripheral areas of the deck where stagnation may lead to solids deposition. Directional valves in these areas increase bubbling activity and promote a uniform flow profile. These components work together to reduce residence time distribution and enhance the fouling resistance of the trays. The final design combines features suitable for specific applications to produce a tray capable of longer run times between cleaning shutdowns. This solution has been demonstrated in similar applications (see **Table 3**). Superflux trays were accepted by NEL and installed during the 2020 shutdown.
